To: The El Camino Real Charter School

Subject: Leak Investigation – Computer Lab

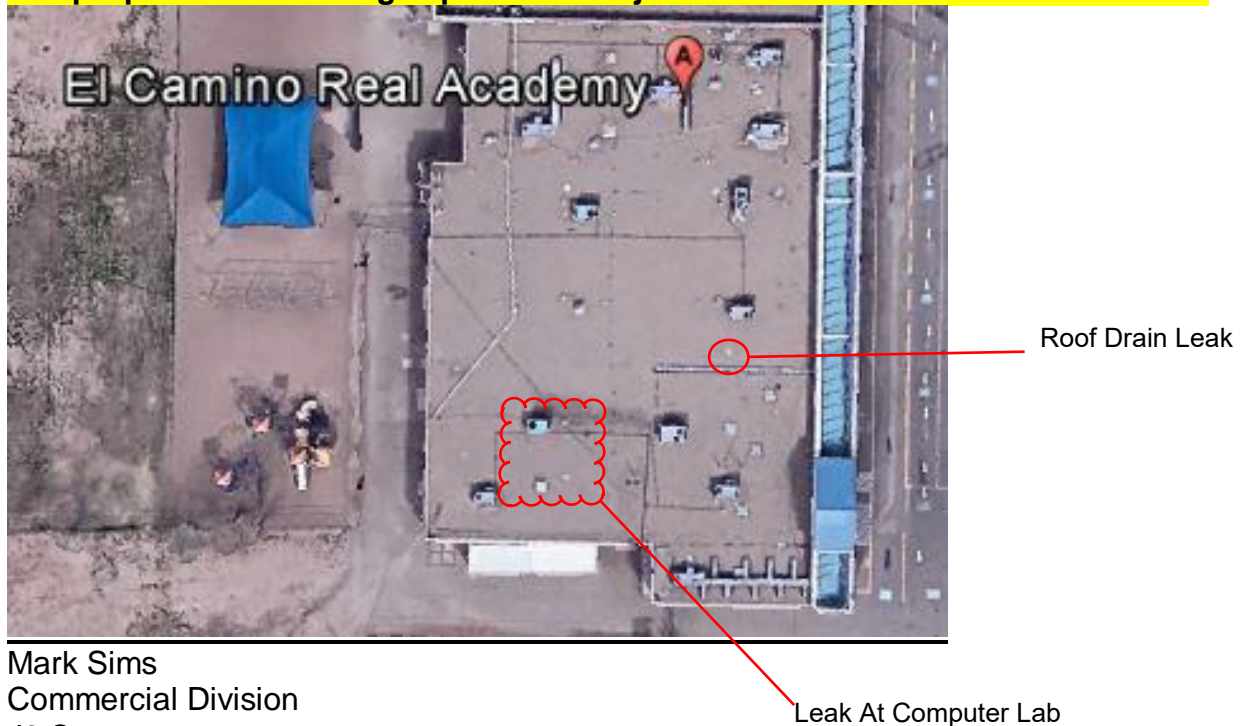
The gravel surface prevents detection of any flaws or defects in the field of the BUR membrane. Based on the amount of water entering the building, the leak could be a minor crack in the membrane, a loose fastener that has punctured the membrane or any split or tear in the membrane.

The leak at the hallway roof drain should be a minor repair, however; the roof deck in this area is gypsum concrete and shows deterioration from long term leaks. There is a potential for deck failure around the drain if the BUR flashing is removed.

The only way to insure the problem has been addressed is to scrape back the flood coat and gravel in an area approx. 25' x 25' and inspect the membrane for defects and repair the entire area. (Please see the attached roof drawing for reference points for the proposed work)
